# I27A Encounter Overview

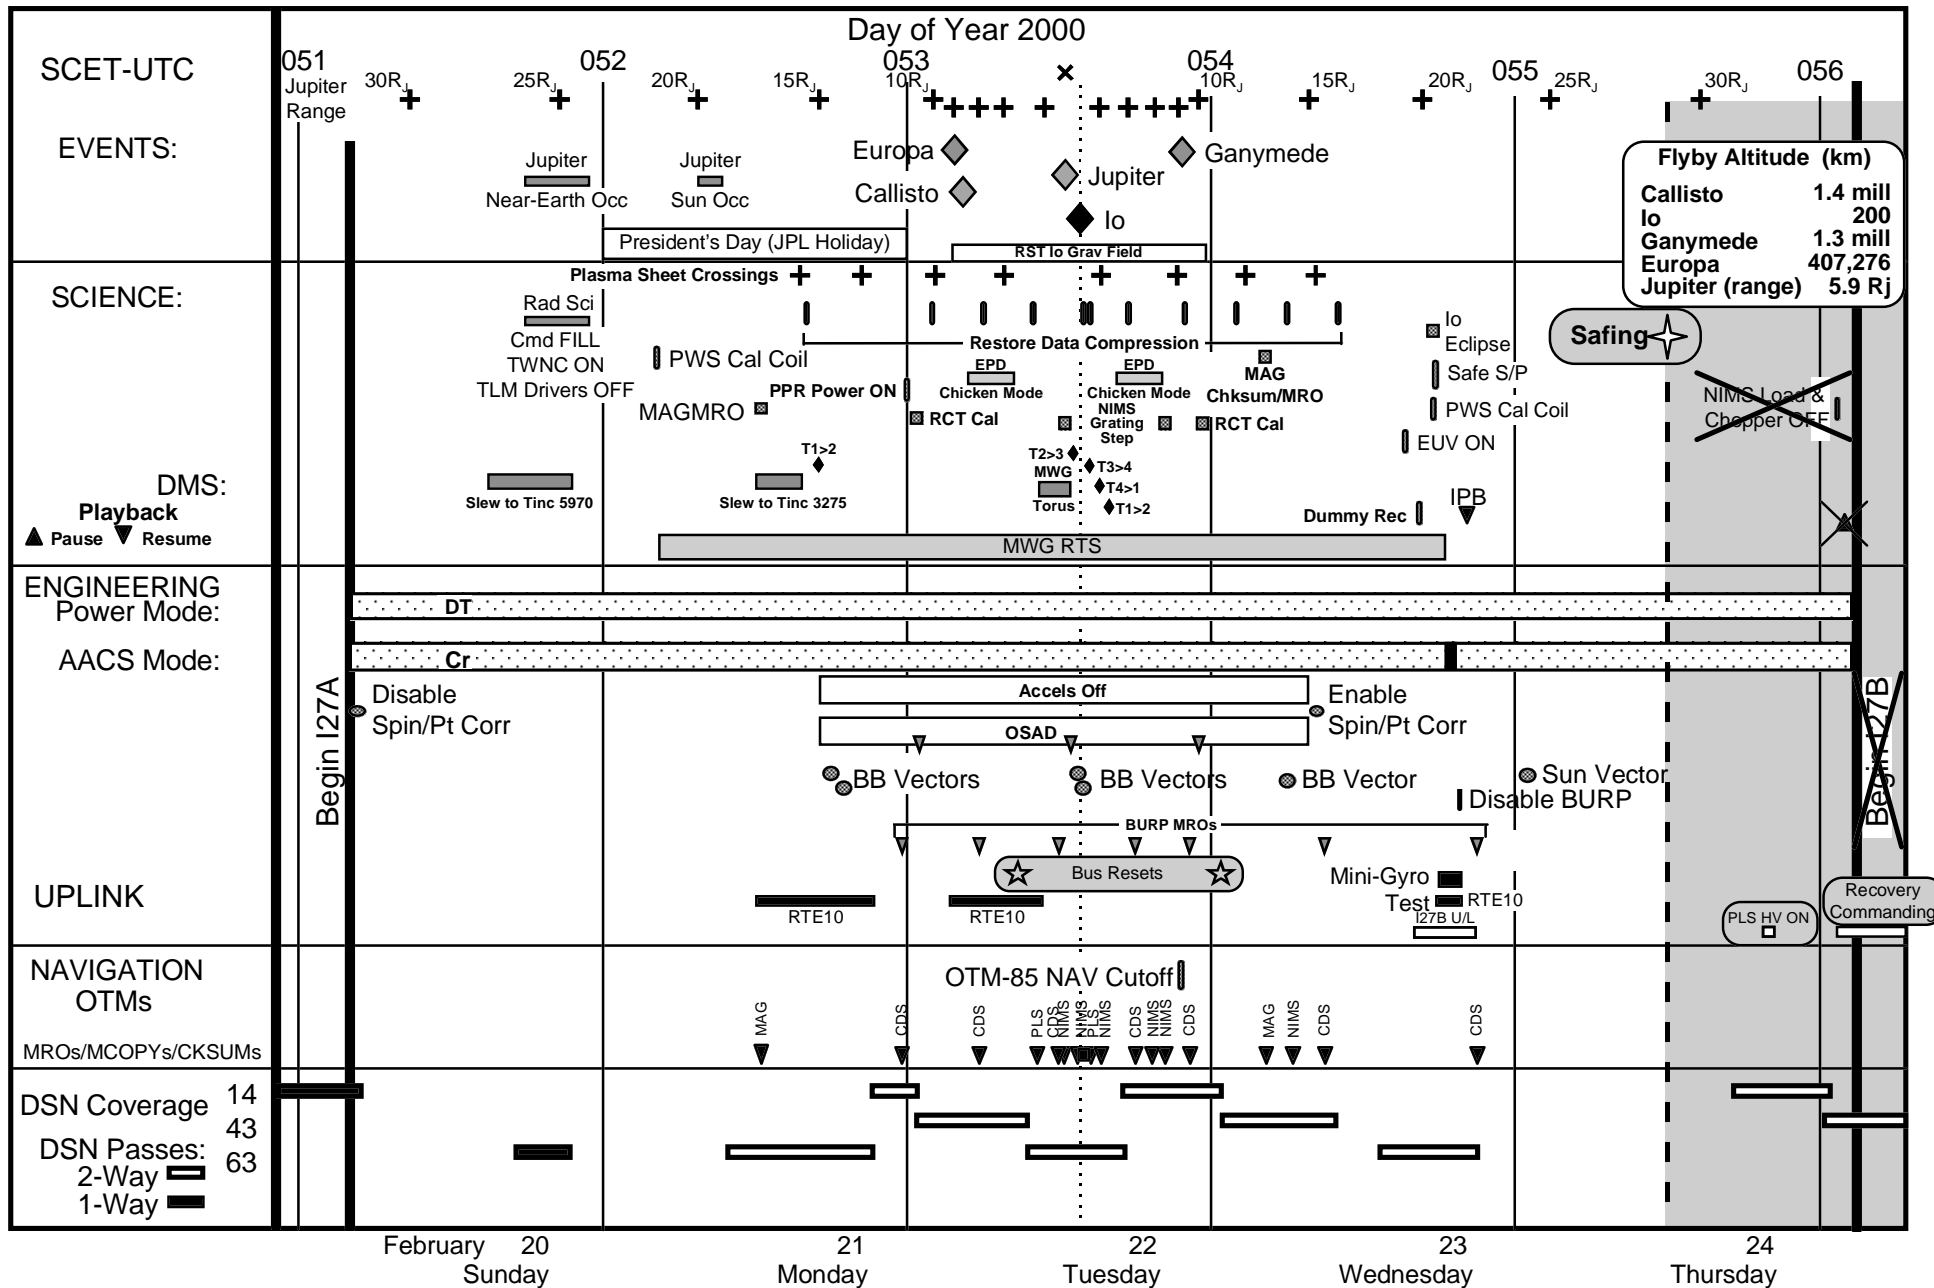
Note: Two Bus Reset PORs occurred during the encounter time period, both of which were properly handled by the on-board recovery routine. The times were: 00-053/08:53:23 SCET and 00-054/00:45-01:45 SCET (indeterminate, MRO not received). Full safeing (due to simultaneous bus reset) occurred at 00-055/12:00:13 SCET.
